POST-FLIGHT INVESTIGATION PROGRAMMES OF RECENTLY RETRIEVED
SOLAR GENERATORS

Lothar Gerlach
European Space Agency—ESTEC (XPG)
Noordwijk, The Netherlands

Abstract

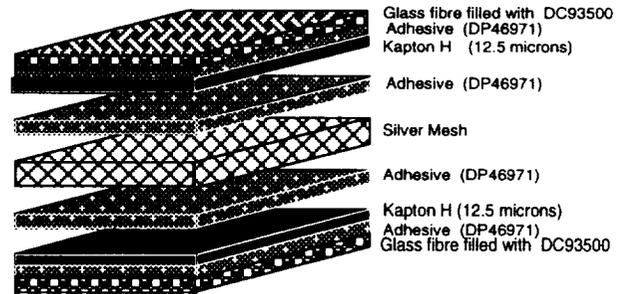
Figure 6: Exploded view of the 0.21 mm - thick, flexible carrier substrate of the SPA, including 50 micron-thick silver mesh for power transfer

As may be seen from the design description HST-SA has identical substrate surface coatings (DC 93500, fig. 6) on the front and rear side of the flexible blankets. Since the solar cell side was always sun oriented, the effect of the contribution of UV radiation to the synergistic environmental effects can be evaluated.

It is of interest to check the silicone adhesives for surface hardening and embrittlement, including depth effects, and to which degree the polymerisation chains have been changed, and also if changes caused the unbonding of the glass-fibre cloth from the Kapton foil (fig. 6 and 11).

DC 93500 was also used as ATOX protection for the flexible substrate (fig. 6). Its darkening under UV light is known and it was no surprise to see a strong discolourations of the blankets. The most pronounced discolouration can be seen on the upper IBA (fig. 7). The portion which was exposed to UV light is very dark over a short stripe of ≈ 10 cm, at a location where there were reflections from the cushion roller. Temperature effects on the discolouration are also seen at the location on top of the power tracks. Other areas were less dark. The unexposed areas were almost as new and had the original colour.

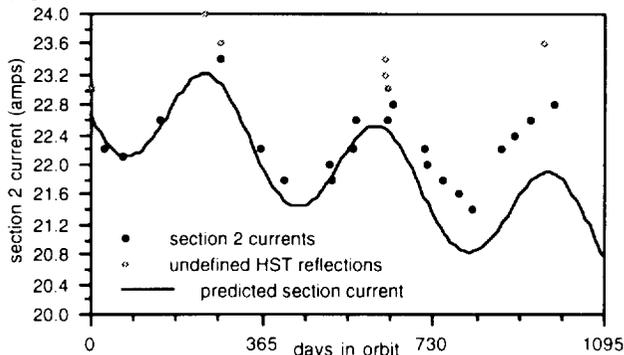
Figure 23. Power profile of SA section 2

The power profile prediction for one typical SA section and actual in-flight data are given in figure 23. After 43.3 months in orbit in-flight data show currents 6% above the prediction.
